Research Report  
KTC-89-11

EARTHQUAKE HAZARD MITIGATION OF  
TRANSPORTATION FACILITIES  
FOR HENDERSON COUNTY

May 1989

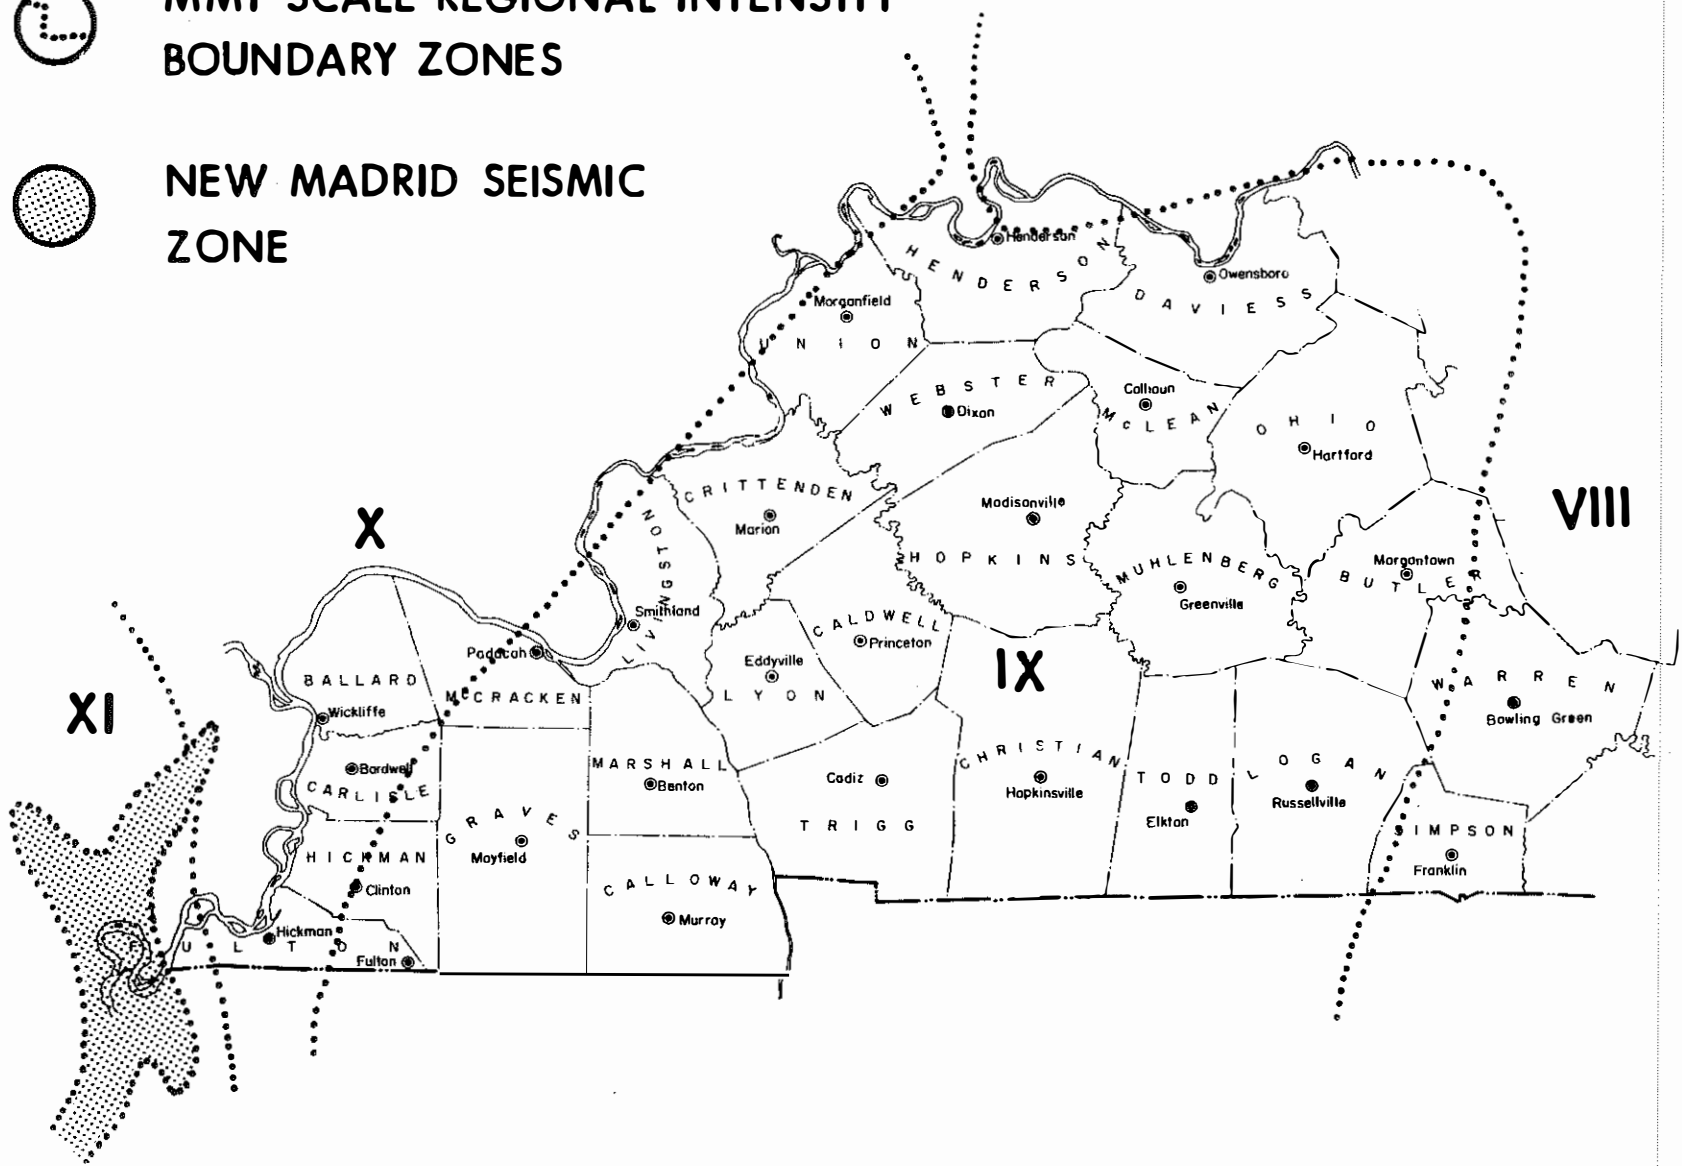
Henderson County is located approximately 120 miles northeast of the center of the New Madrid Seismic Zone. Figure 1 indicates that

Henderson County is located in the X, IX, and the VIII bands of the MMI scale. Approximately 85 percent of Henderson County is located within the IX band. This indicates considerable damage could occur in Henderson County in the event of a major earthquake.

Figure 1: The twenty-six counties included in this study area.

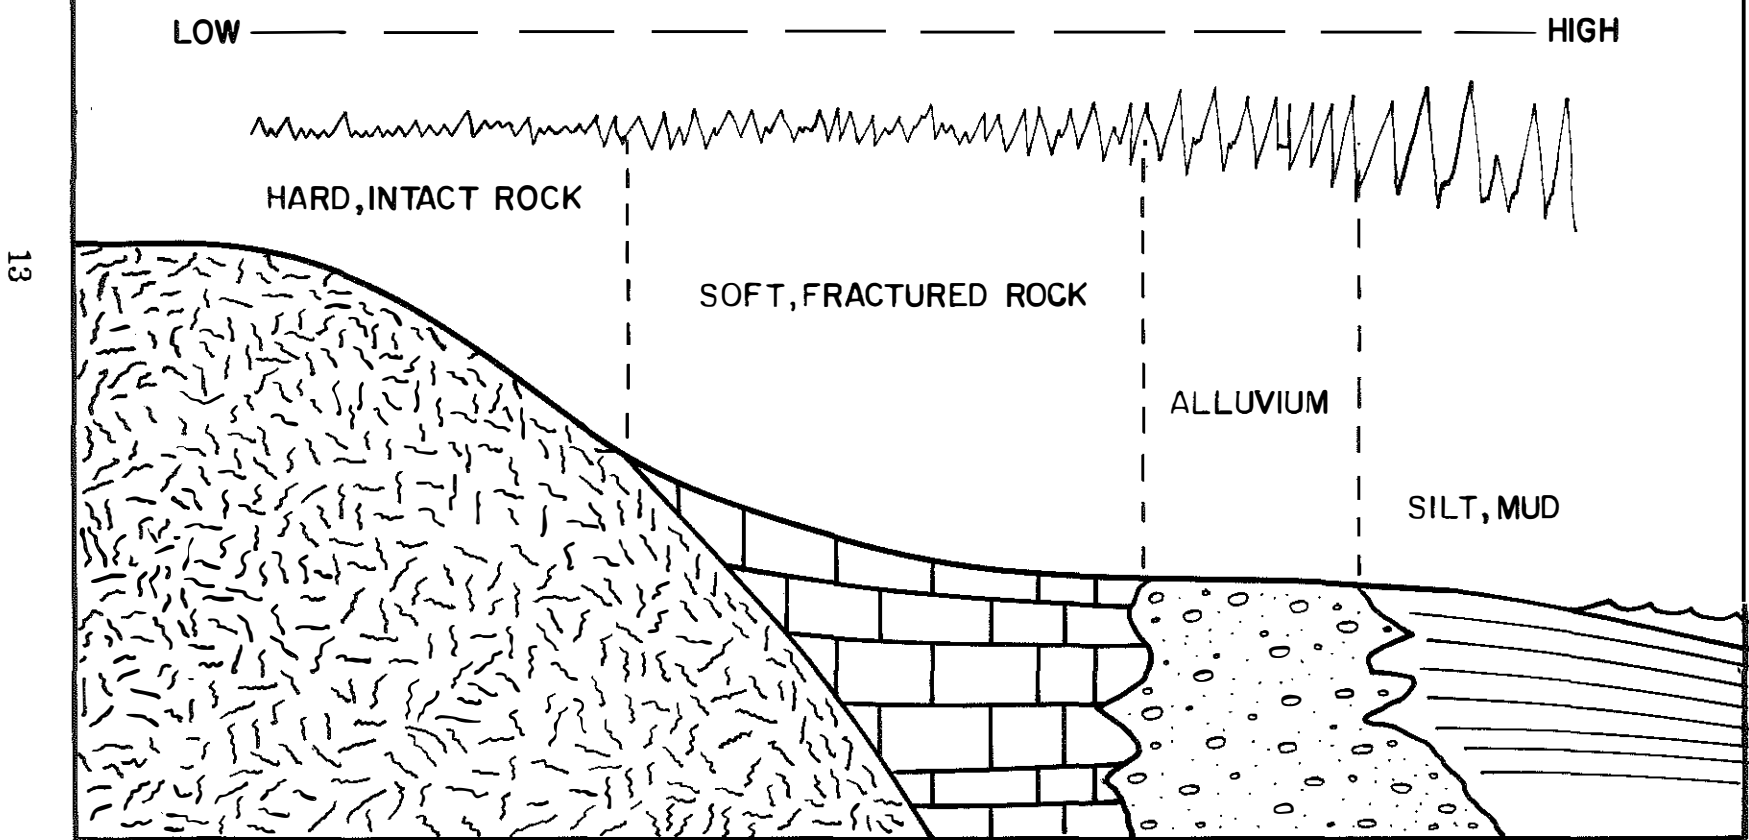
Figure 2 : Amplification of shaking in softer rock & soil during an earthquake.

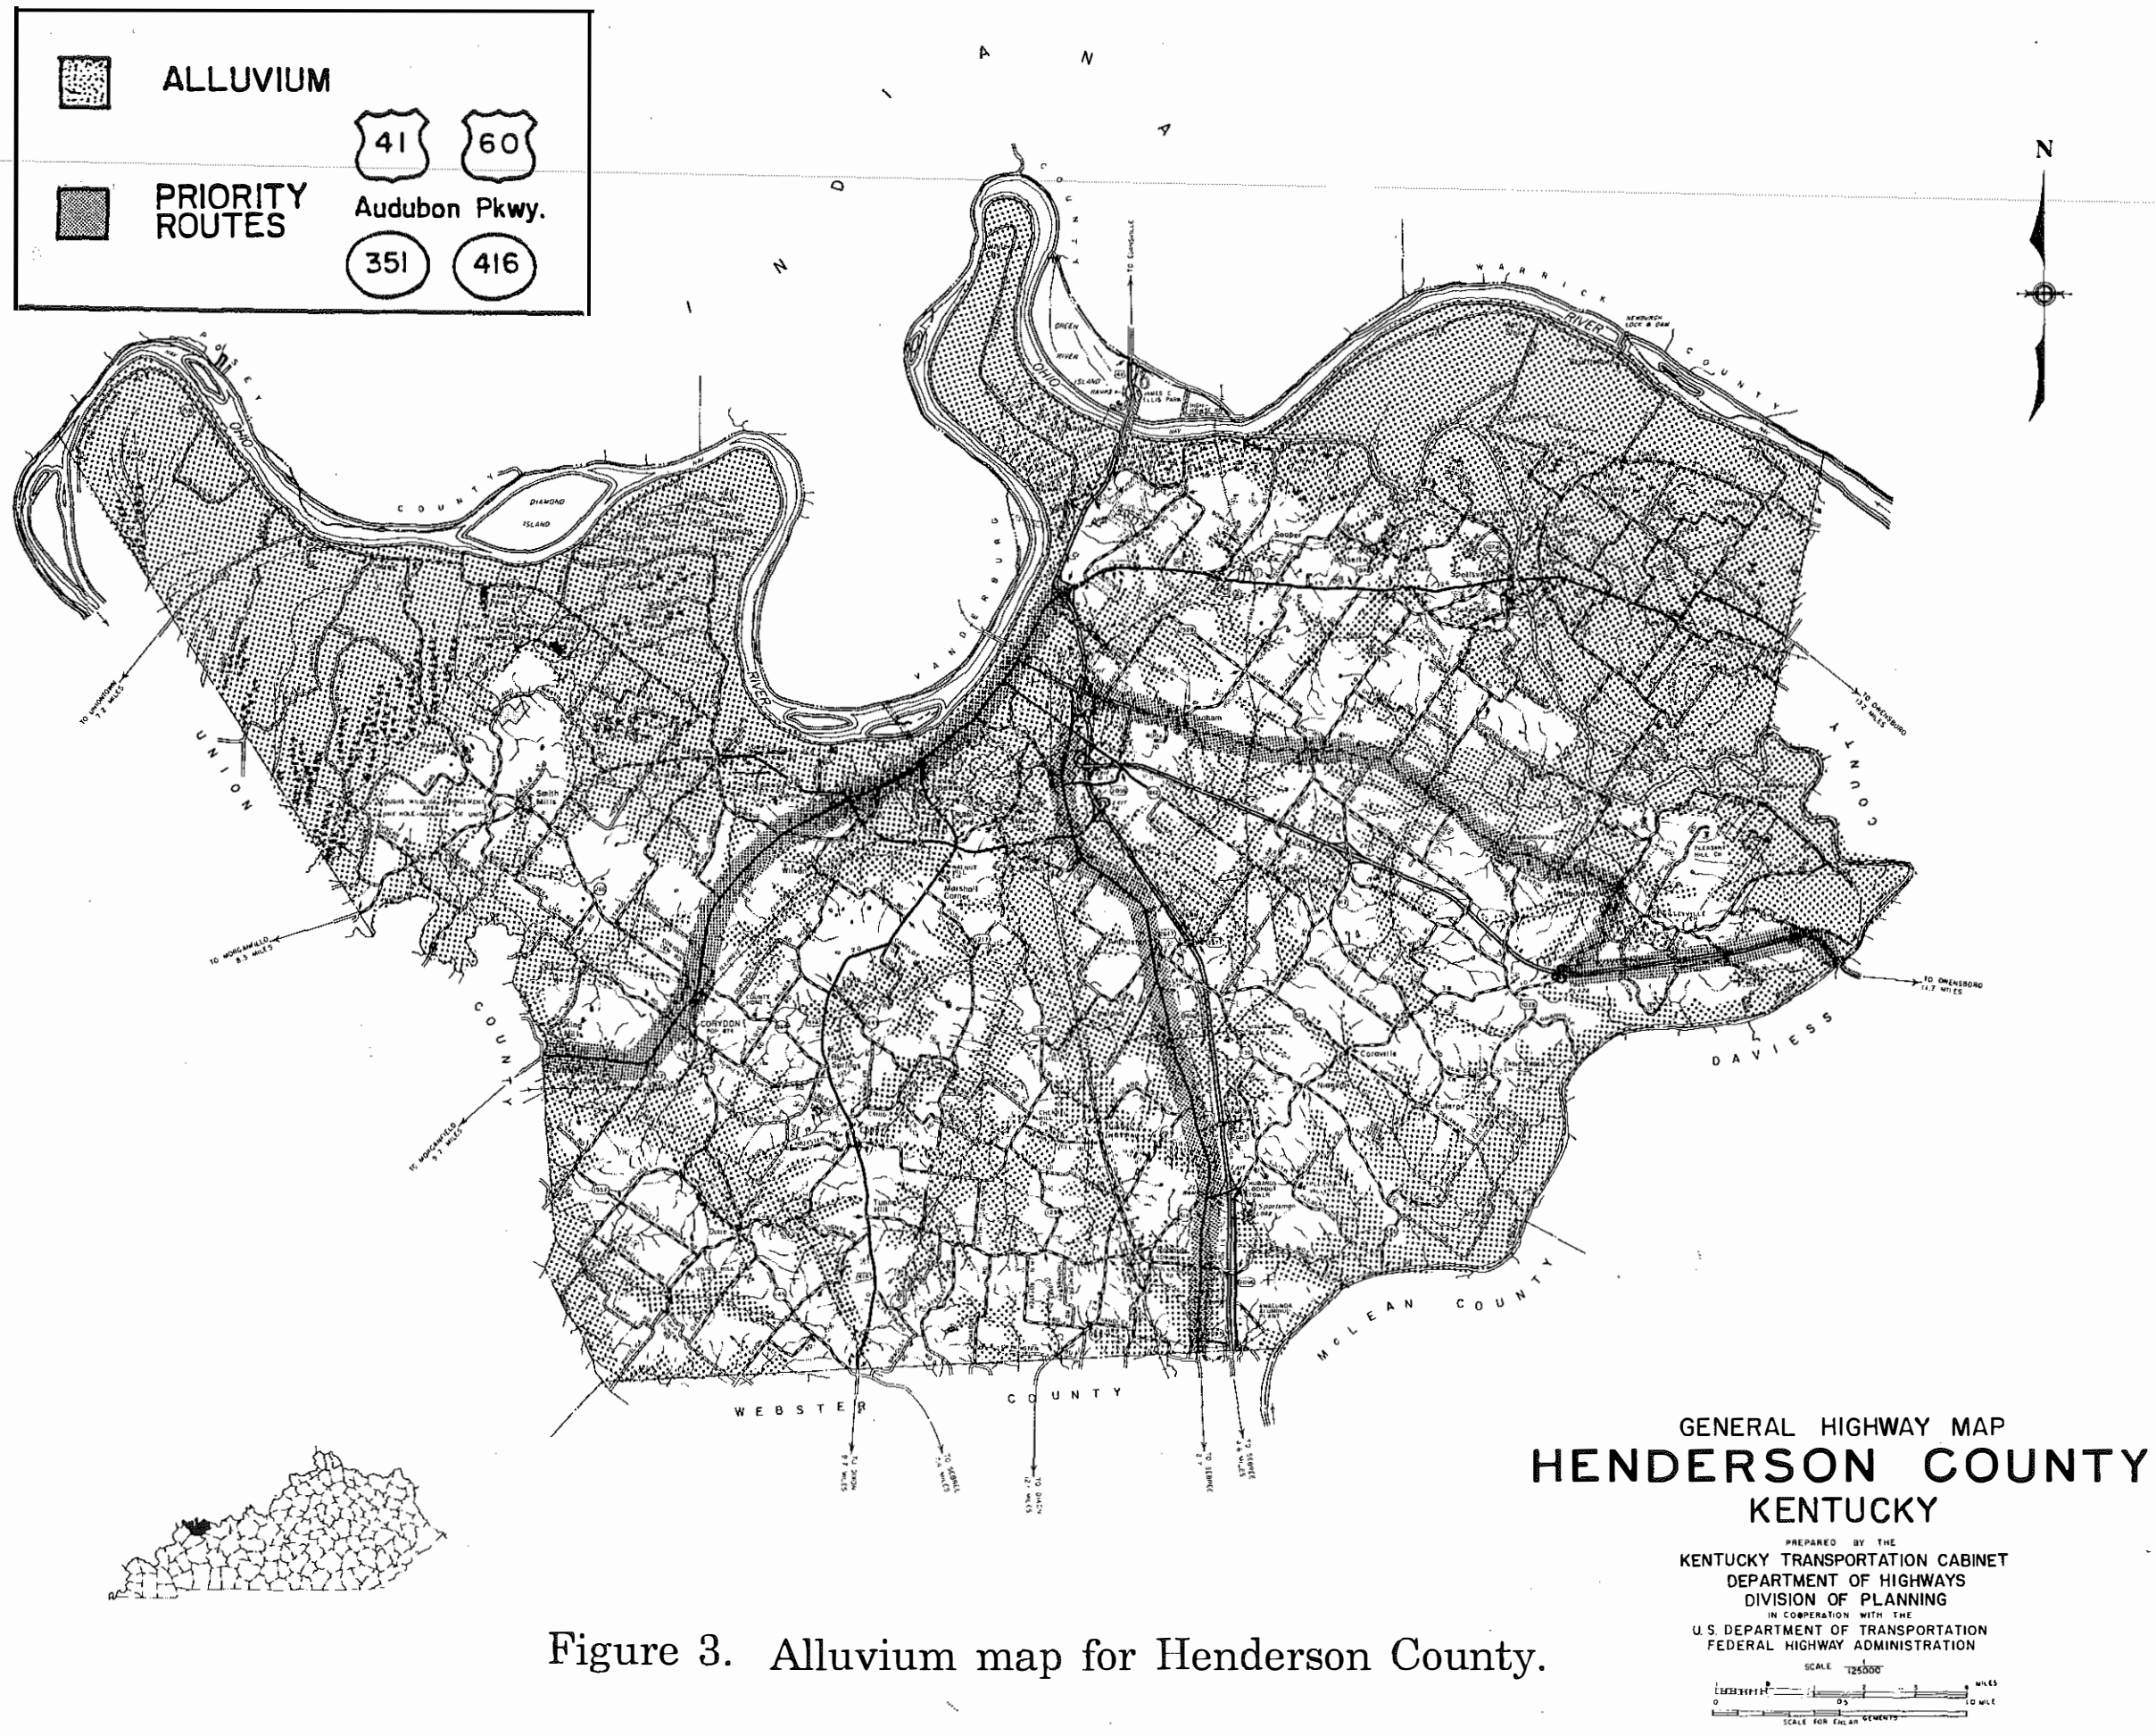
Soil maps for Henderson County indicate that there are large amounts of alluvium present throughout the county. Alluvium is a loose, fine-grain soil which is deposited by flowing water such as

Figure 3. Alluvium map for Henderson County.
